ALERT SERVICE BULLETIN

Checking of the correct positioning of sealing plug in ignition housing for ROTAX® Engine Type 912 i (Series)

ATA System: 24-20-00 Internal generator

MANDATORY

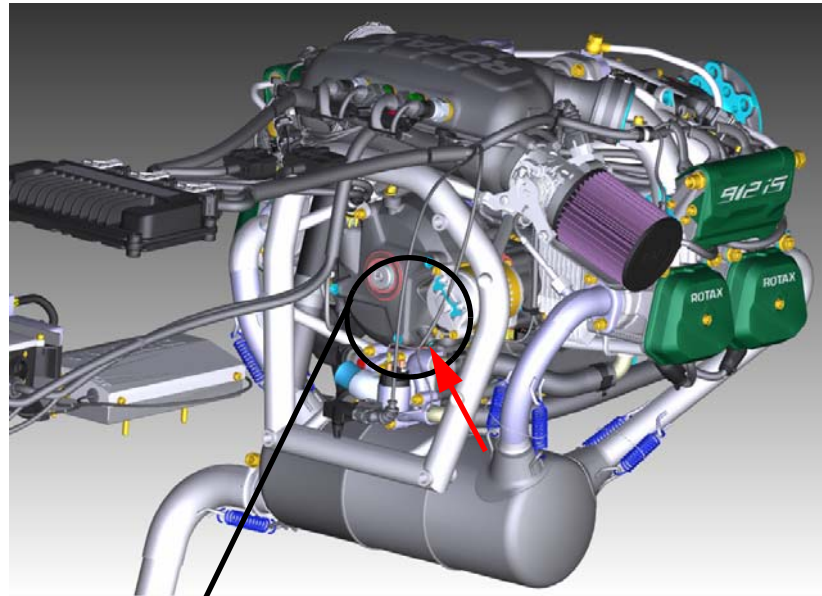
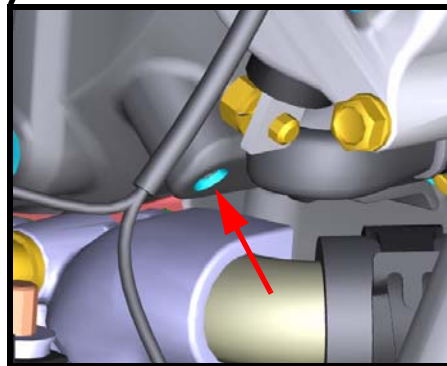
Fig. 1
Sealing plug in ignition housing

Field observation has shown that in isolated cases the sealing plug (see Fig. 1) was not pressed to its correct seating position in the ignition housing. In rare cases this may lead to loss of oil and subsequently loss of lubrication which leads to engine stoppage.

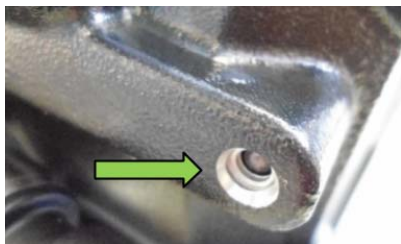
Step	Procedure
1	Check the position of sealing plug in the relevant area of ignition housing assy. See Fig. 2.
2	The sealing plug must show to have been pressed in until the top of the ball is below the edge of the sleeve. See position OK in Fig. 2.
3	If you notice sealing plug position is OK, then there is no need for further procedures. NOTE: If you notice sealing plug position is NOT OK, then see section 3.2.

Sealing plug position "OK"

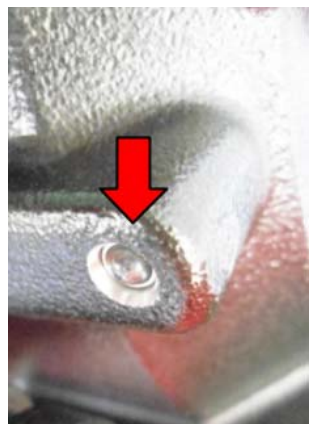
Sealing plug position "NOT OK"

Step	Procedure
1	<p>Correct the sealing plug position with a hammer (max. 300 g / 0.66 lbs) and the relevant insertion jig part no. 676255 as per section 2.6. Intuitively control your manual insertion force just to set the ball in correct position. See Fig. 3.</p> <p>NOTE: The bore must be free of oil, grease and chips.</p> <p>NOTE: Make sure to insert the insertion jig in correct alignment of the center bore / center line of the sealing plug.</p>
