## SERVICE BULLETIN

# Periodic checking of the crankshaft journal (power take off side) for ROTAX® Engine Type 912 and 914 (Series)

ATA System: 72-20-00 Engine block

## MANDATORY

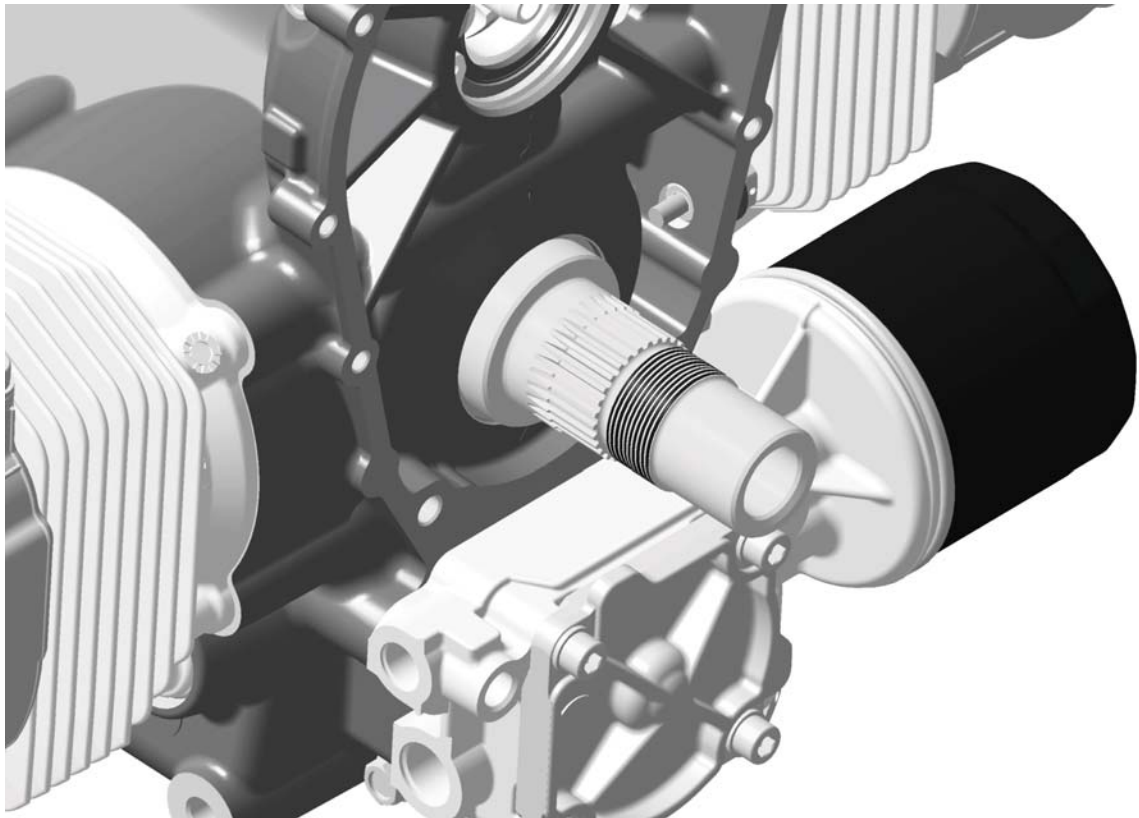
**Fig. 1**  
**Crankshaft journal**

Due to a deviation in the manufacturing process some crankshafts may develop a crack on the power take off side. These cracks can cause breakage of the crankshaft in the support bearing during operation. In this case the function of the support bearings (consisting of 3 main bearings and 2 support bearings) is compromised. The operating reliability, however, is given until the next maintenance.

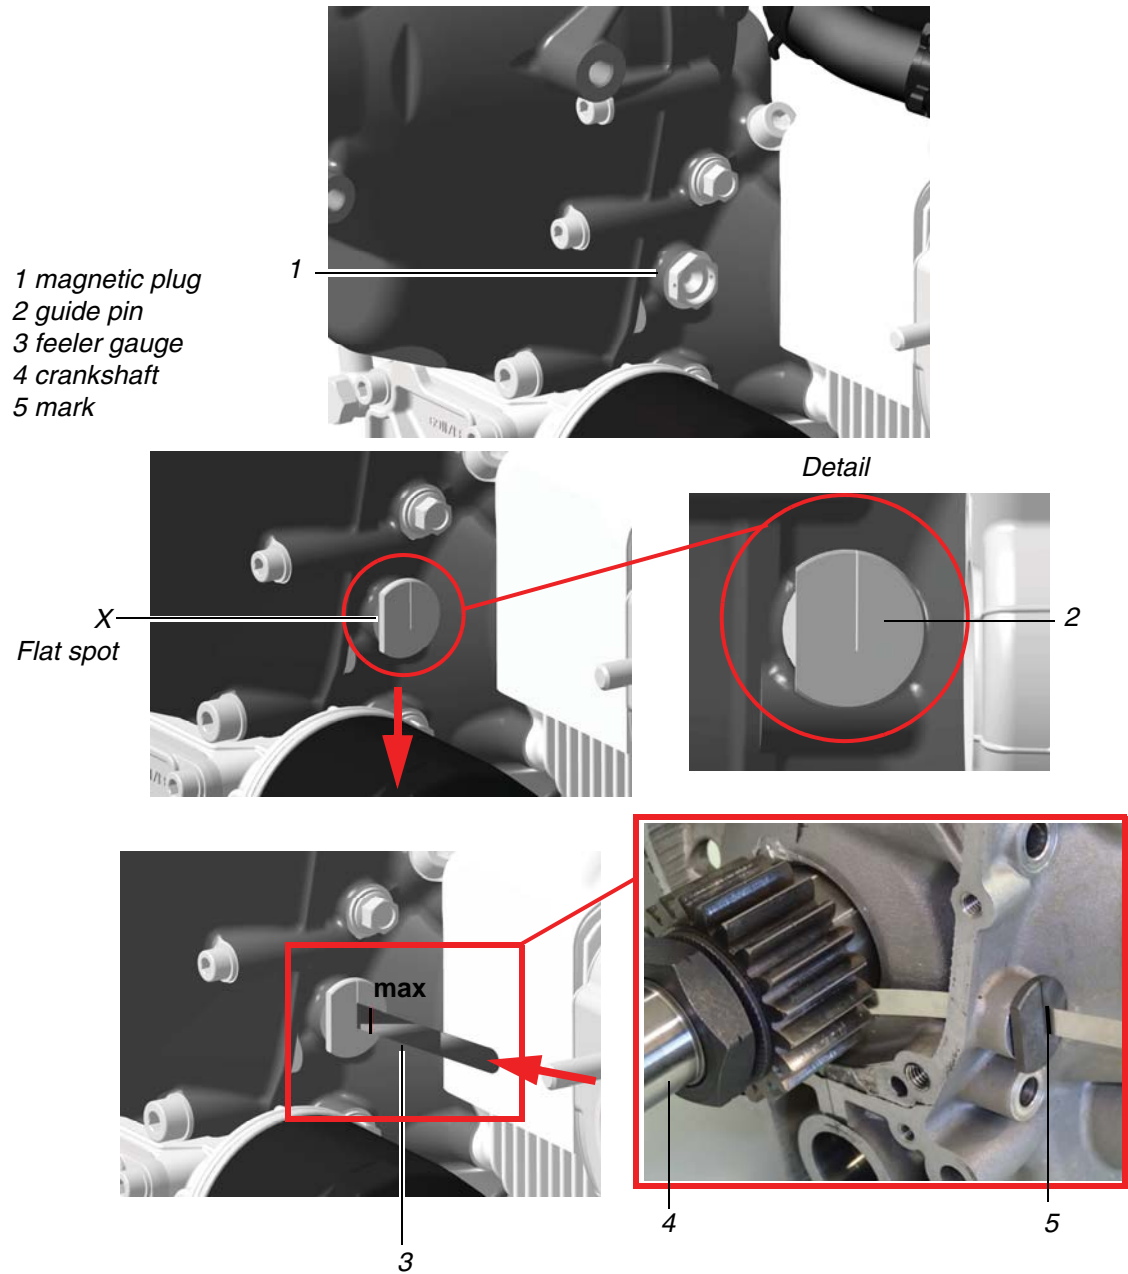
**Fig. 2**  
**Inspection with feeler gauge**

Step	Procedure
1	Remove the magnetic plug in accordance with the relevant Maintenance Manual (Line).
2	Install guide pin (2) of the check gauge CS-PTO into the magnetic plug thread until stop. Adjust the guide pin with the flat spot (X) in the direction of the propeller and parallel to the gearbox/housing contact surfaces. Hold it in fixed position not allowing any rotation. Pliers or an open-end spanner can be used.
3	Insert feeler gauge of check gauge CS-PTO into the guide pin. NOTE: The feeler gauge is symmetrical, both sides can be used.
4	Insert feeler gauge until a first resistance can be felt. Now the feeler gauge faces the cylindrical crankshaft journal (see Fig. 3, Step. 1).
5	With slightly elevated force you can push the feeler gauge about 2 mm (.078 in.) further in, until it touches the plan surface of the pinion gear (see Fig. 3, Step. 2). NOTE: The mark on the feeler gauge is still visible outside the slot.

Step	Procedure
6	Push the check gauge into the guide pin with increased force and make sure that the guide pin has not turned. If the drive gear is in correct position and cannot be moved the crankshaft is OK. The feeler gauge cannot be further moved in and the mark (5) remains visible outside the slotted screw.
<b>Result = Crankshaft journal OK</b>	
7	Remove the check gauge CS-PTO (feeler gauge and guide pin).
8	Install the magnetic plug in accordance with the relevant Maintenance Manual (Line).

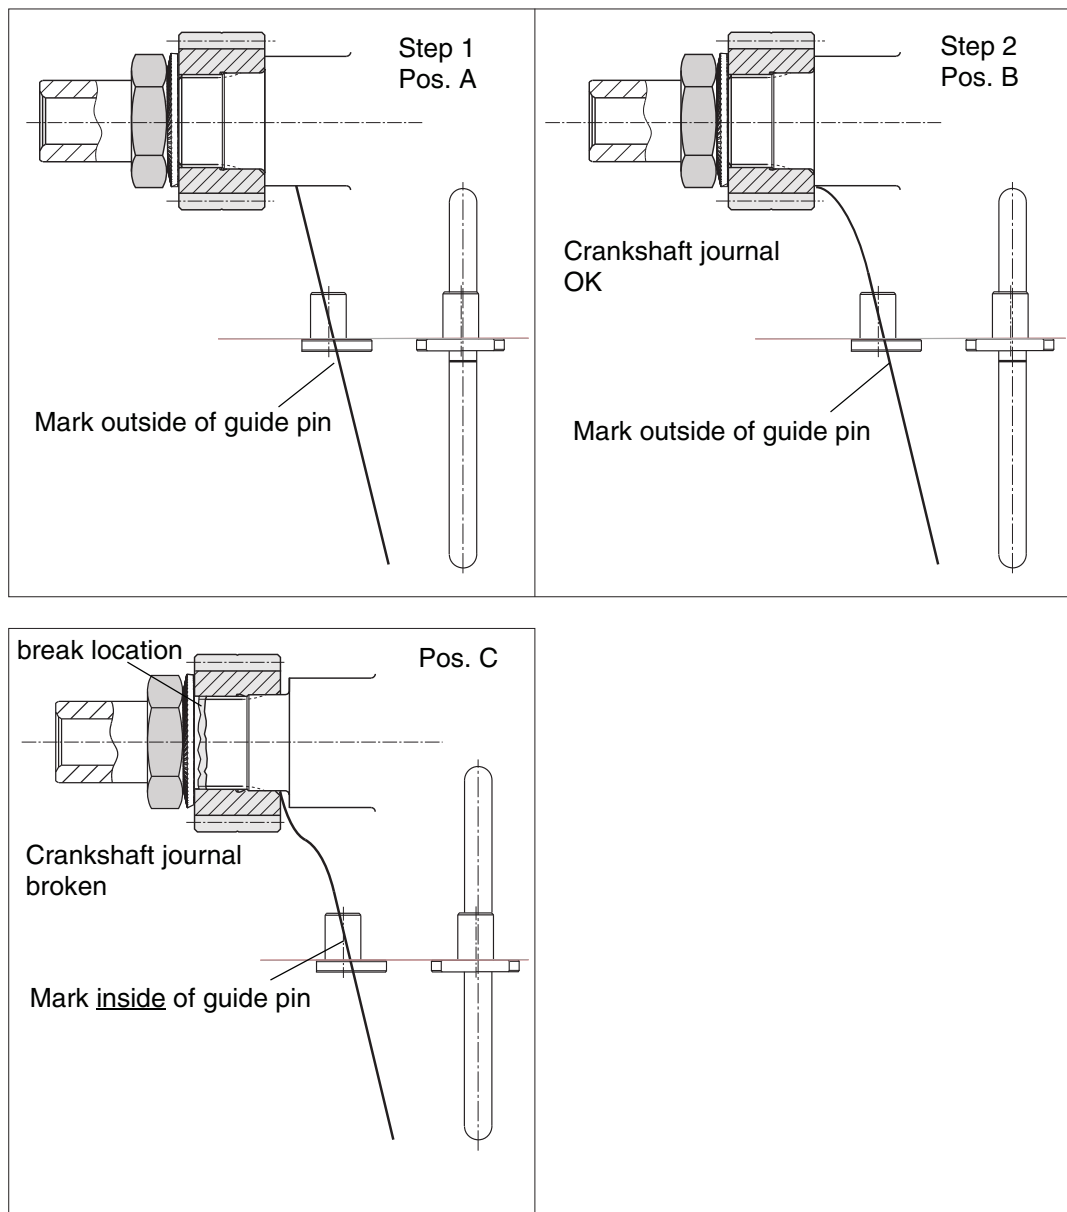
Fig. 3

Step	Procedure
6	Hold it in fixed position not allowing any rotation. If the feeler gauge can be pushed further in, so that the mark disappears in the slot, then the gearbox must be removed and the crankshaft must be checked (see Fig. 3, Pos. C).
<b>Result = Crankshaft journal broken</b>	
7	Please find further explanations if needed in this chapter 3.2).

The replacement of the crankshaft is only necessary, if inspection result 2 is applicable.

- In case of a broken crankshaft journal or any doubt contact your aircraft manufacturer and your nearest authorized ROTAX® aircraft engine distributor.
